REPORT

April 6, 2021

ASTM Phase I Environmental
Site Assessment
108 Hydeville Road
Stafford, Connecticut

Funded through the EPA Brownfields
Assessment Grant Number BF-00A0036

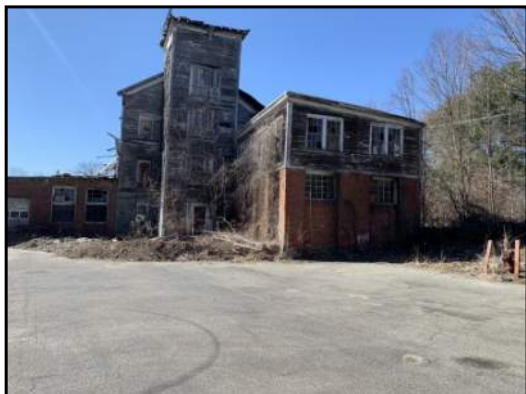
1 : View of the front of the Mill building from the asphalt parking lot. View to the west.

2 : Gated entrance to the south side of the Site with pile of fill material to the left. View to the west.

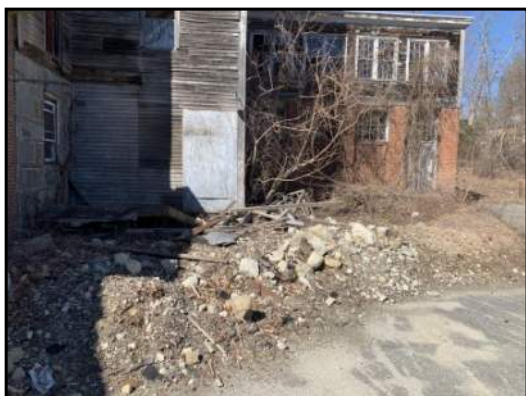
3 : Building Debris along the east side of the Site building. View to the north.

4 : A pile of fill material of unknown origin placed along the south side of the asphalt parking lot. View to the east.

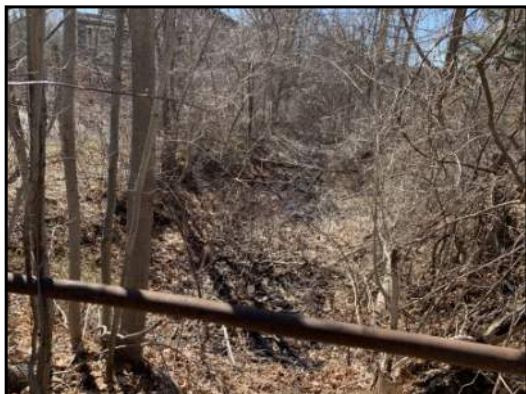
7 : The Mill Race, when flowing, runs to the west to the Mill, beneath the Mill, and discharges to Furnace Creek. View to the west.

8 : Access along the north side of the Site. Pole-mounted power lines are not in service. View to the west, with the Mill Race along the left side of the photograph.

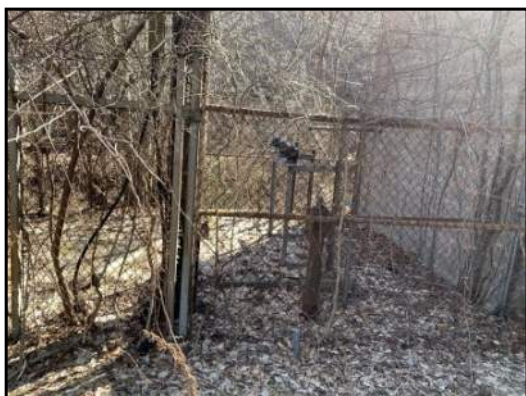
9 : Location of former transformer pads along the north side of the Mill Race. View to the south.

10 : Front (east) side of the former carding portion of the Site building. View to southwest.

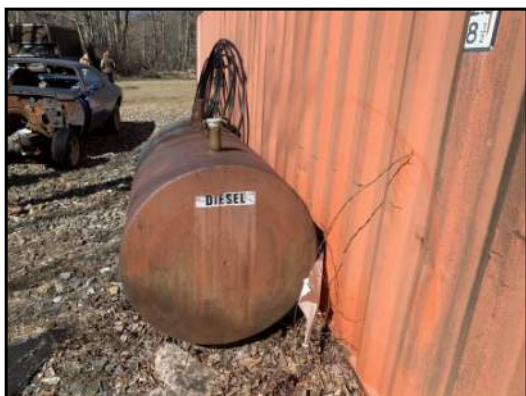
15 : Empty diesel AST (AST #1) along the west side of the shipping container. View to the north.

We recommend the completion of a Phase II ESA and a hazardous building materials assessment.

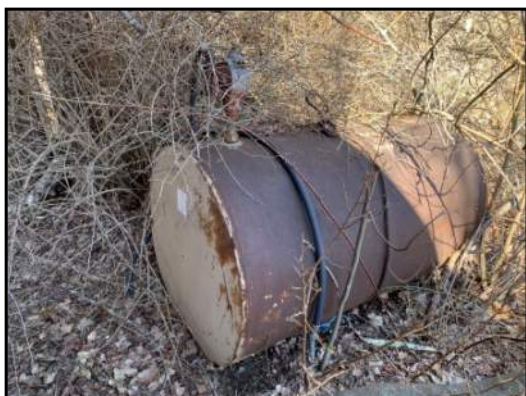
21 : Empty AST on adjoining property to north next to the brown package truck.

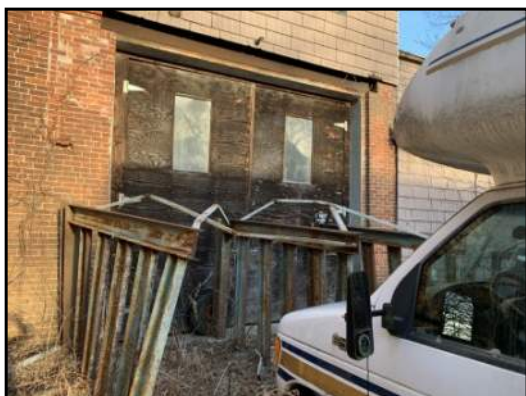
26 : Sewer manhole on southwest corner of Site. Possible location of original septic tank. View to the northeast.

27 : Loading dock off the west side of the Site building. View to east.
